3 EXISTING BUILDING CONDITIONS

3.1 BUILDING ANALYSIS & SUMMARY

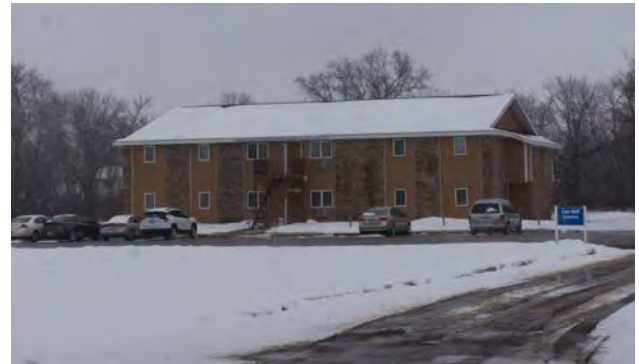
CANBY

Carr Residence Hall was constructed in 1973. The two-story building accommodates eight, two-bedroom apartments. Parking and an outdoor recreation area are provided adjacent to the residence hall. The residence hall is not fully occupied; each year there are one or two apartments available.

The apartments are in satisfactory condition, although there are issues that should be addressed.

- The outside entries are uninviting. Each floor has a main, exterior entry (an exterior stair leads to the upper level) but there are no gathering space inside the main entries.
- The building lacks common space and laundry facilities.
- Interior finishes and furniture are dated and worn.
- The residence hall lacks an outdoor patio/gathering space; students walk across the campus and use the grill and patio at the commons area.

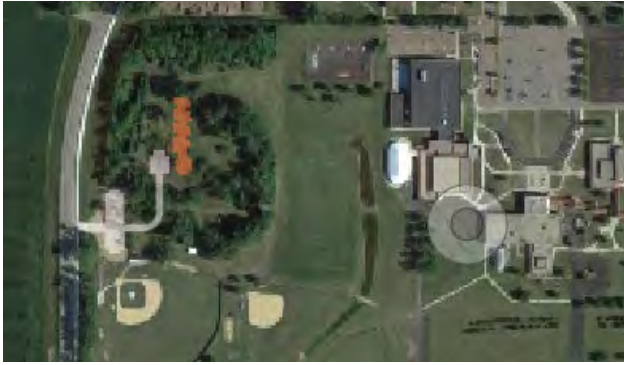
WORTHINGTON

Bluejay Villas is a new campus residence hall that opened in the fall of 2018. The three-story building contains 108-beds in a combination of two-bedroom/two bathroom and four-bedroom/four-bathroom units. It also includes a commons area with laundry and fitness facilities, a social area, a study room, mailboxes, vending and a manager's office.
