3.2 BUILDING DATA SHEETS

The following pages detail the age, size, current replacement value, backlog of repairs, five-year renewal forecast and facility condition index values for each building on the five MWCTC campuses. The Building Data Sheets also include a summary of the building use (with color-coded space type plans), utilization data (with associated plans), descriptions of building systems (HVAC, electrical and technology) and analysis of current issues.

CANBY CAMPUS BUILDINGS SUMMARY

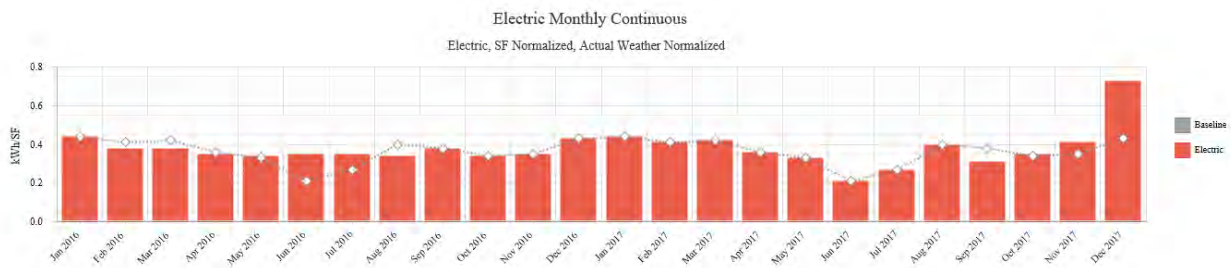
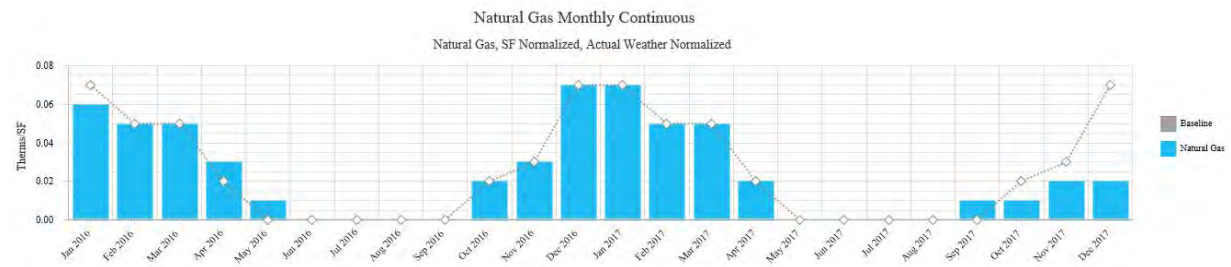
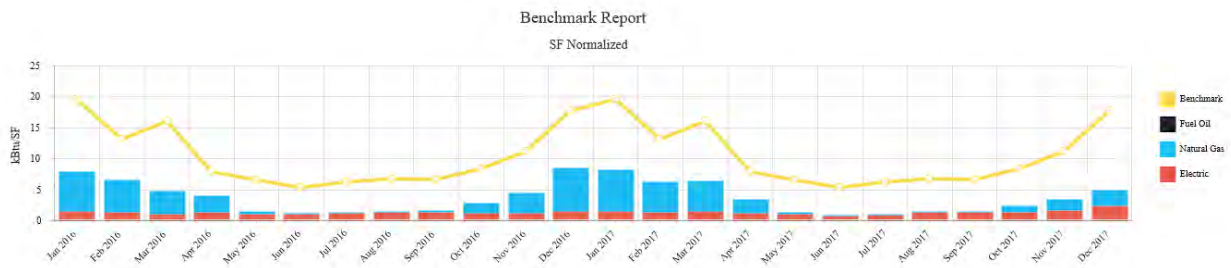
In 2009, Minnesota State Colleges and Universities started using the B3 system, establishing the baseline for energy use. The information below reflects the MWCTC Jackson campus's energy use of both natural gas and electricity. The baseline shows how the site would perform in subsequent years if no changes or improvements had been made.

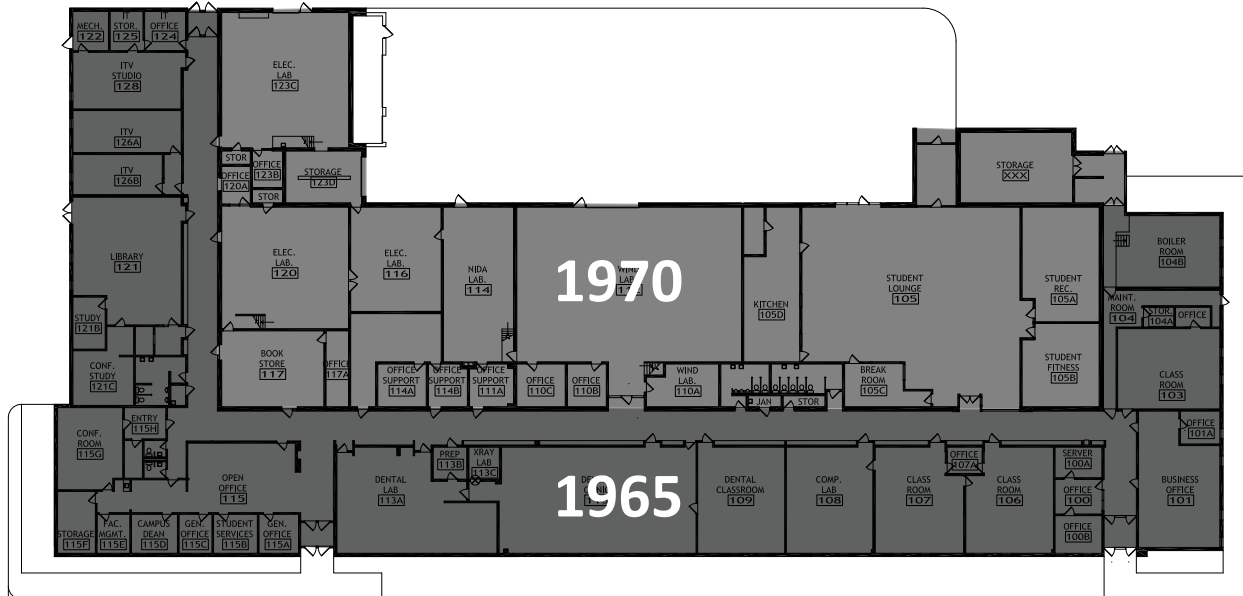
ADDITIONS/RENOVATIONS BY YEAR

Englund Orig. Bldg.	Englund Addition
Year Constructed	1965	1970
Gross Square Footage	22,000	21,913
Current Replacement Value (CRV in 000's)	\$8,220	\$7,999
Building Repairs Backlog	\$818	\$98
Facility Condition Index	0.10	0.02
5-year Renewal Forecast	\$1,110	\$1,006
Mothballed	NA	NA
Roof Type	4-Ply Asphalt	4-Ply Asphalt
Building Exterior Type	Masonry	Masonry
Sprinklers	N	N

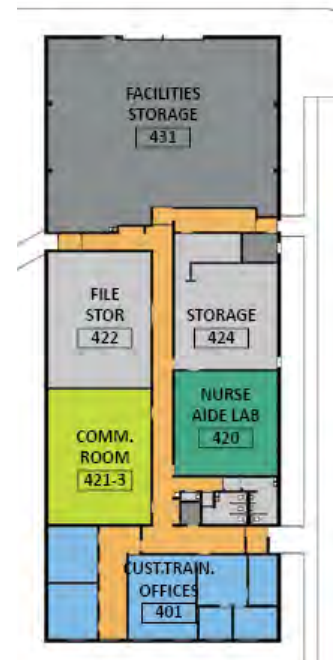
The plan below shows the rooms types by color. The 1976 building provides space for the Customized Training Program offices, community gathering/meeting, nurse aide training and facility storage. Large community events are held in the community room. Outside of the cafeteria/dining in Englund Hall, this is the largest meeting space on campus, but the interior is dated. Significant interior upgrades are needed, in addition to planned HEAPR requests to re-skin/insulate the exterior and replace the roof.

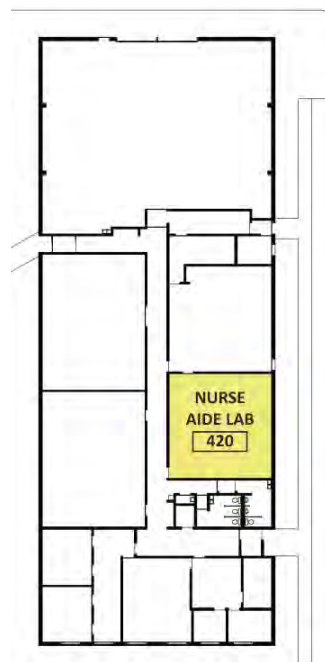
SPACE UTILIZATION

The space utilization diagram indicates low usage for the Nurse Aide Lab. All other spaces are used for other functions such as offices, testing, storage or community gathering.

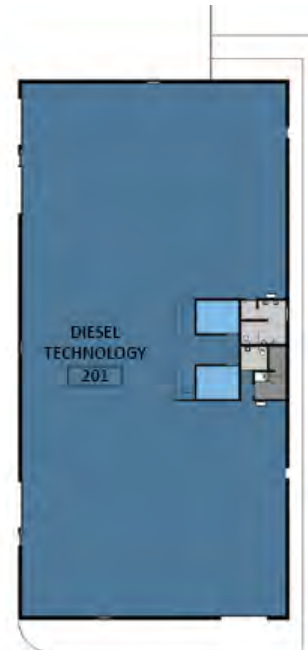
The plan below shows the rooms types by color. This 1974 building is used entirely as lab space for the Diesel Technology program. Some office space and storage space is included, as well as recently renovated toilet rooms.

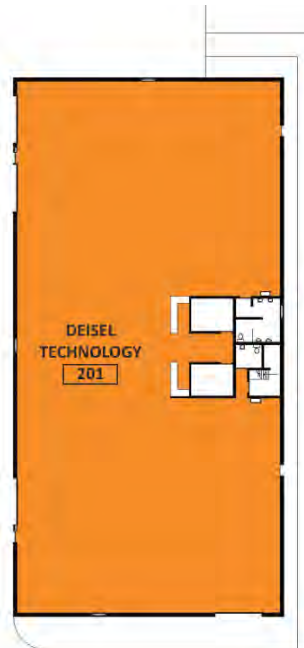
SPACE UTILIZATION

The space utilization diagram indicates medium usage for the Diesel Technology teaching/lab space.

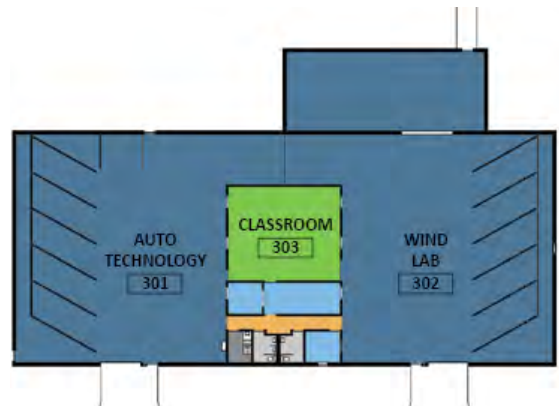
The plan below shows the rooms types by color. This 1976 building is used primarily as lab space for the Automotive Technology program. It also contains a classroom, storage for Wind Technology, and office space.

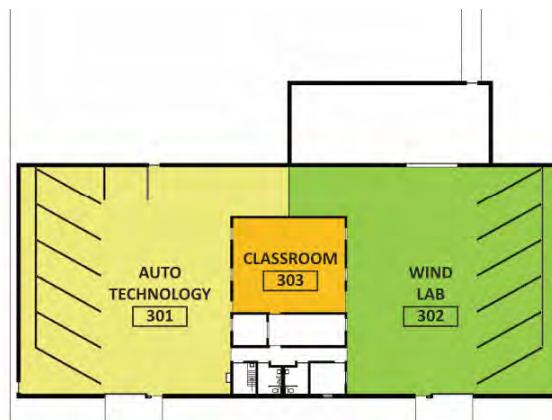
SPACE UTILIZATION

The space utilization diagram indicates very low/low usage for the Automotive Technology teaching/lab space and classroom. The Wind Lab area is coded as unused.

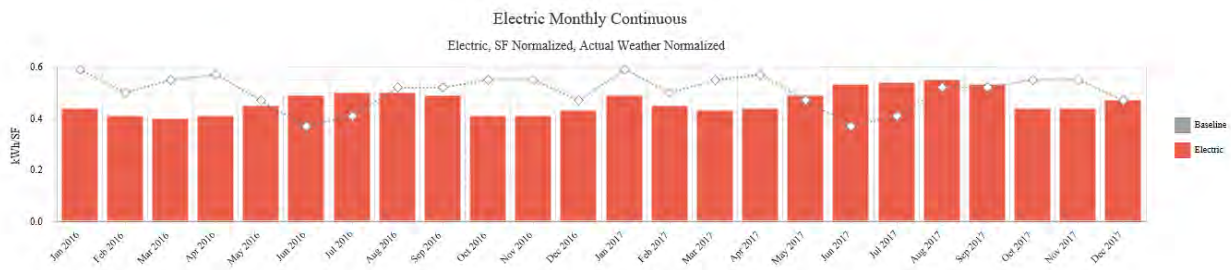
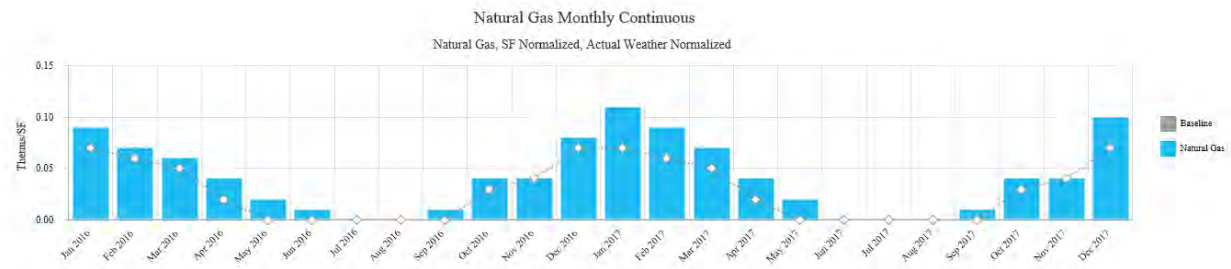
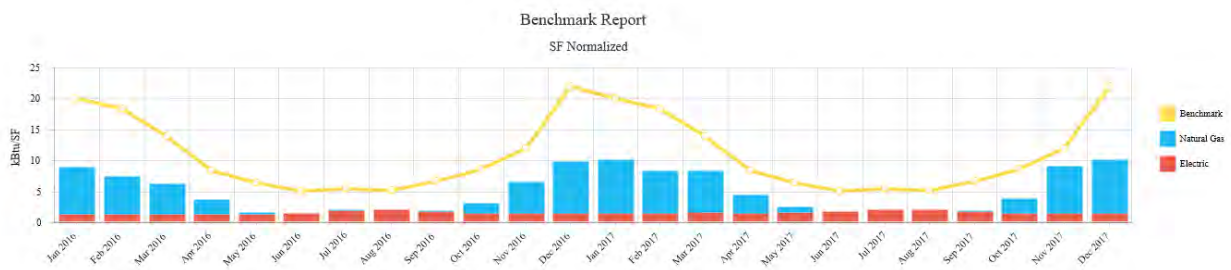
B3 DATA ANALYSIS

In 2009, Minnesota State Colleges and Universities started using the B3 system, establishing the baseline for energy use. The information below reflects the MWCTC Granite Falls campus's energy use of both natural gas and electricity. The baseline shows how the site would perform in subsequent years if no changes or improvements had been made.

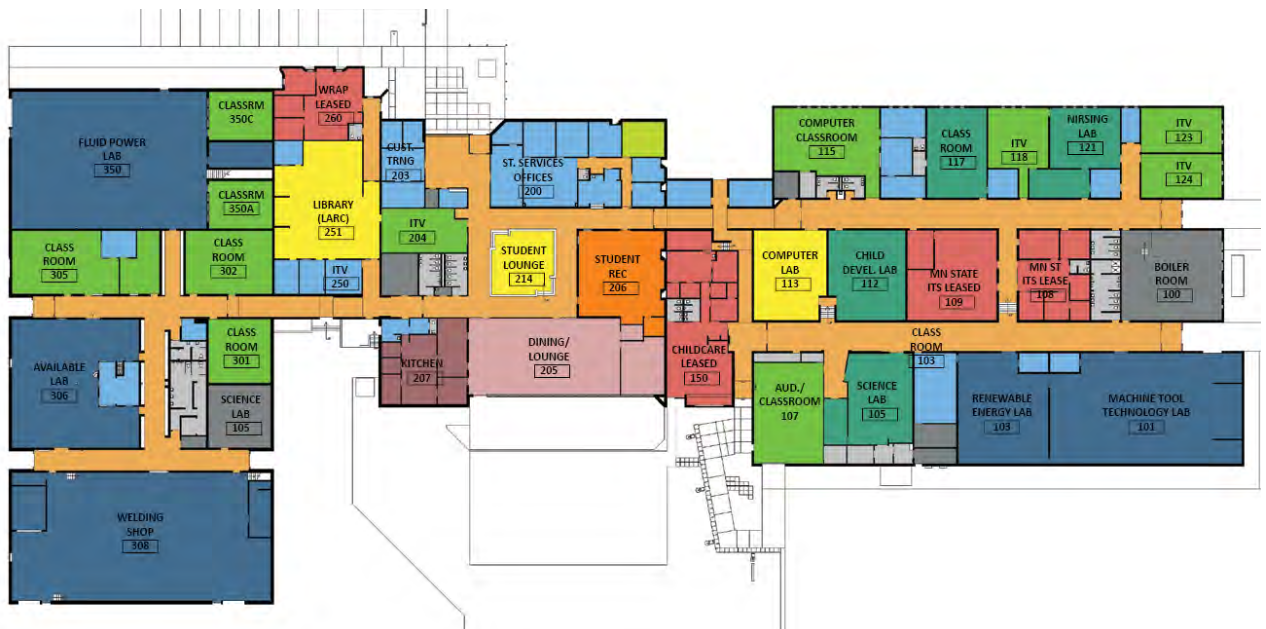
The plan below shows the rooms types by color.

Use Type	Granite Falls	
	SF	%
Classroom	10,900	12%
Labs	5,200	6%
Technical Lab	21,900	24%
Library & Study Areas	4,500	5%
Subtotal Academic Area	42,500	48%
Offices	7,200	8%
Conf/Meeting	0	0%
Rec/Athletics	1,600	2%
Stud Support/Other	0	0%
Arts Area	0	0%
Cafeteria/Bookstore	3,000	3%
Kitchen	1,200	1%
Leased Space	6,200	7%
Support & Mech./Maint. Space	5,900	7%
Circulation	21,800	24%
Total Net Area	89,400	100%

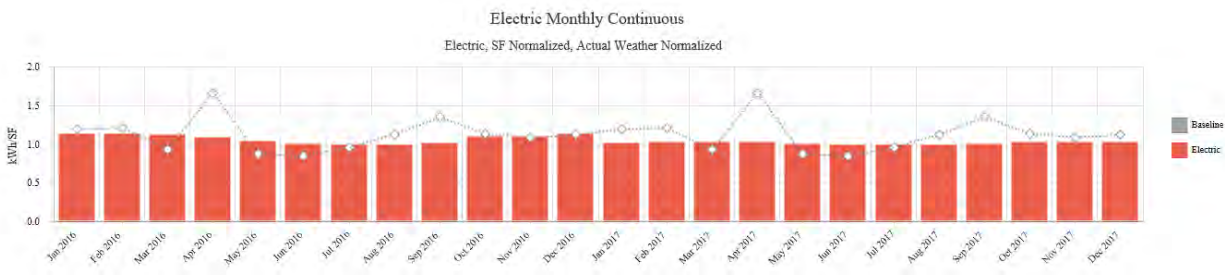
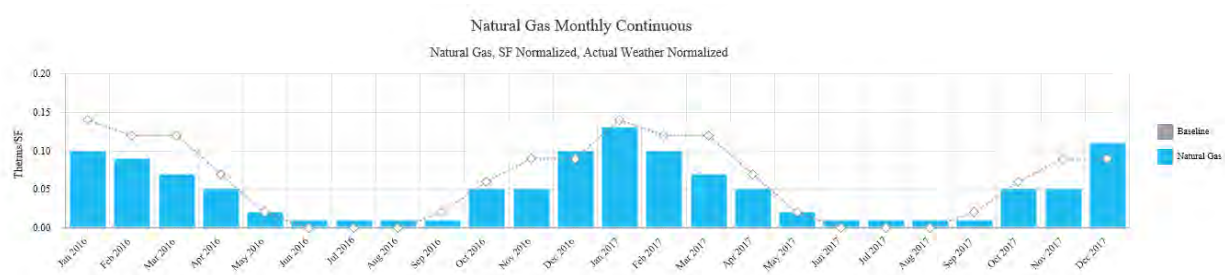
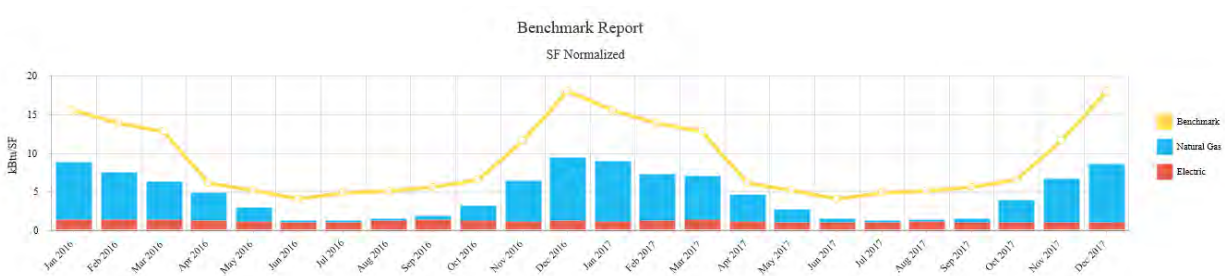
B3 DATA ANALYSIS

In 2009, Minnesota State Colleges and Universities started using the B3 system, establishing the baseline for energy use. The information below reflects the MWCTC Jackson campus's energy use of both natural gas and electricity. The baseline shows how the site would perform in subsequent years if no changes or improvements had been made.

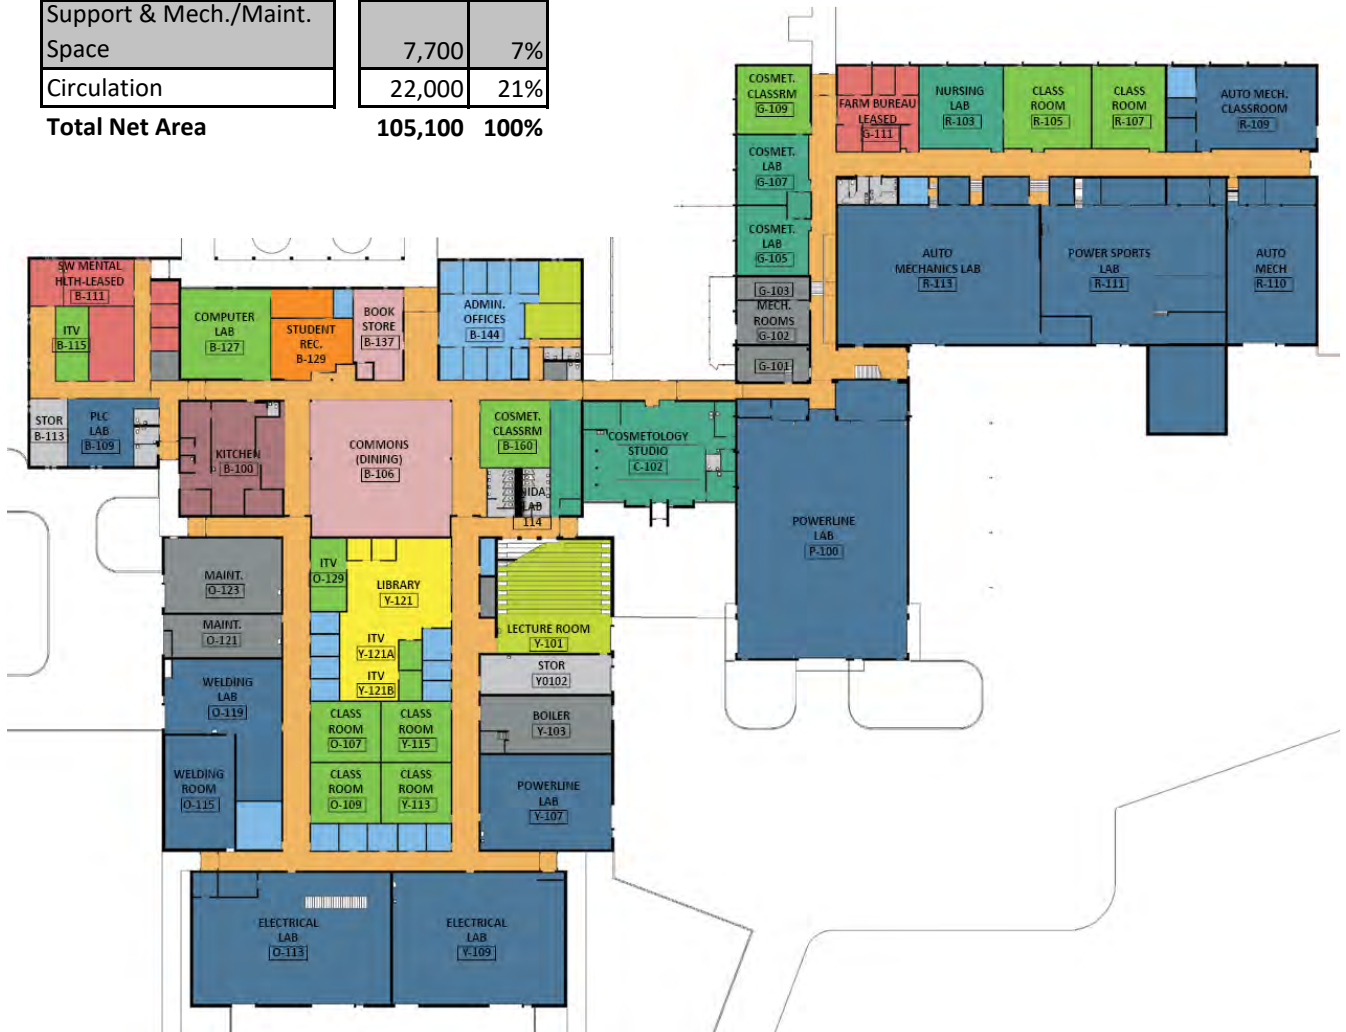
EXISTING SPACE USAGE

The plan below shows the rooms types by color.

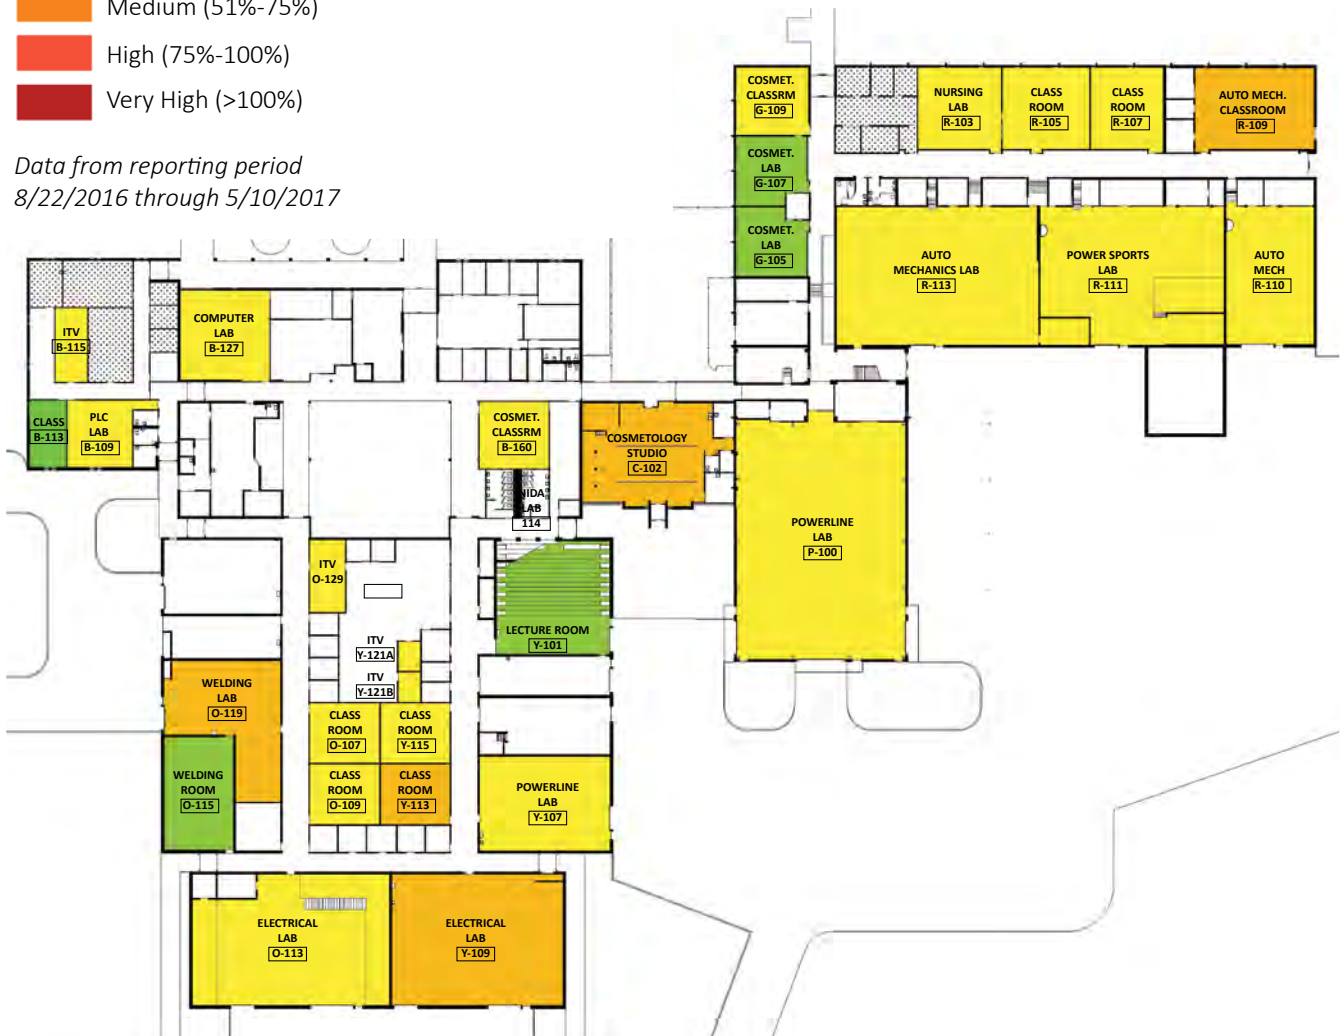
SPACE UTILIZATION

- Reporting is for academic credit courses only and may not reflect other non-credit courses such as continuing education or customized training.
- Lab spaces are specialized and not adaptable for other uses. Utilization may not reflect the need for clean-up/set up time between classes.
- Room scheduling inconsistencies may not reflect the true usage rates of these spaces. Scheduling procedures are under refinement/review. (The current usage reflects reports generated prior to the refinement/review process.)

Data from reporting period 8/22/2016 through 5/10/2017
